Appendix A14.1
Scheme Walkover
Summary

Appendix A14.1: Scheme Walkover Summary

The following is a summary of the observations by the Land, Soils, Geology and Hydrogeology Environmental Impact Assessment Team following a physical walkover of the Ballymun / Finglas to City Centre Core Bus Corridor Scheme (hereafter referred to as the Proposed Scheme). The walkover occurred on 7 February 2020 and 9 July 2021.

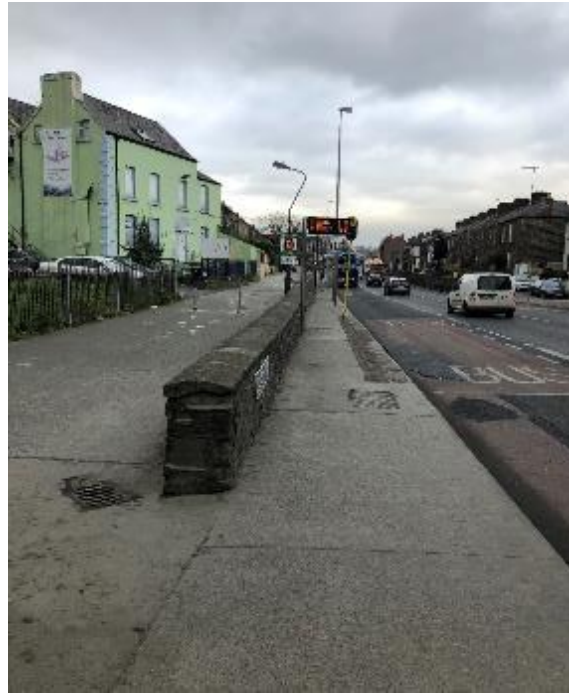
Photo ID	Caption	Date Taken	Coordinates
Ballymun_Image01	Level change and retaining wall – Phibsborough Road	7/2/2020	714926, 735257 (ITM)

Observation	General Arrangement Drawing Sheet Number*	Description	Possible Impact	Photo Number
Phibsborough Road	16	Retaining walls were noted along this section of the route. It may require minor level changes, construction of a new retaining wall and earthworks to accommodate the works.	This may pose an issue for the earthworks balance and waste assessment.	Ballymun_Image01
Royal Canal Bank	13	Widening road in area where old canal may have been and subsequently infilled, new proposed cycle bridge to be constructed across the canal. Possible source of contamination.	This may pose an issue for the earthworks balance and waste assessment and mobilising contaminants into the groundwater.	Ballymun_Image02 & 03
Bequileme Bridge	13	Significant earthworks will be required to create an underpass under the existing bridge. The composition of the fill surrounding the bridge is unknown.	This may pose an issue for the earthworks balance and waste assessment and mobilising contaminants into the groundwater.	Ballymun_Image04

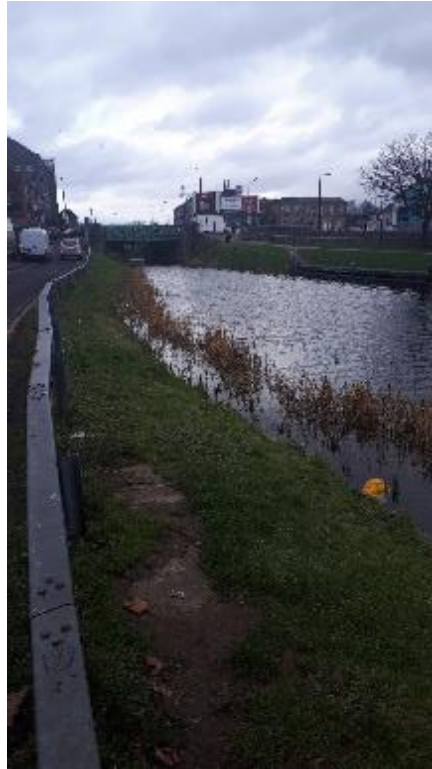
Photo ID	Caption	Date Taken	Coordinates
Ballymun_Image03	Proposed location for a new cycle bridge across the canal	07/02/2020	715086, 376255 (ITM)

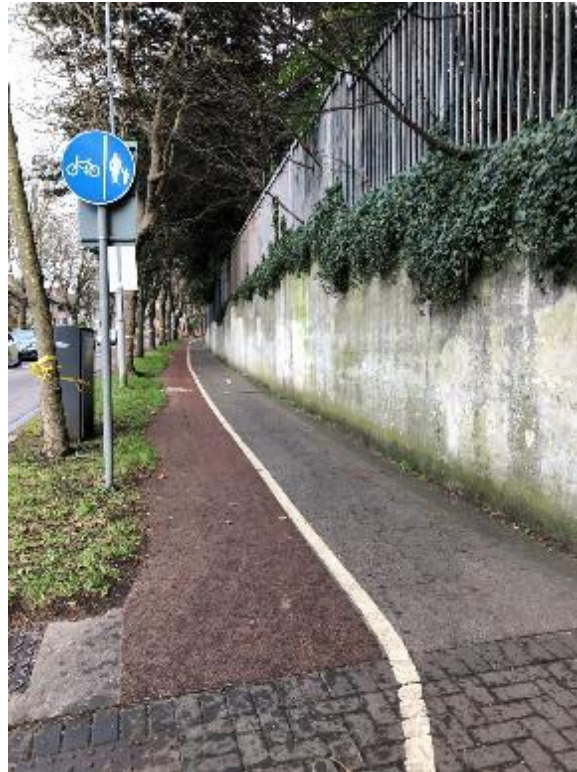
Photo ID	Caption	Date Taken	Coordinates
Ballymun_Image05	Mobhi Road Widening	07/02/2020	715429, 737288 (ITM)

St. Mobhi Road widening	08 - 10	Retaining walls were noted along this section of the route. It may require minor level changes, construction of a new retaining wall and earthworks to accommodate the works.	This may pose an issue for the earthworks balance	Ballymun_Image05
Cycle track and proposed location of construction compound B2 along the River Tolka	10	Minor level changes were noted across the area, this may require minor earthworks to accommodate the works. This is also the location of a potential construction compound.	This may pose an issue for the earthworks balance and waste assessment and mobilising contaminants into the groundwater	Ballymun_Image06
Petrol Stations	Various	Historic activities at petrol stations may have resulted in oil leaks into the surrounding soils and groundwater in the past.	This may pose an issue for the earthworks balance and waste assessment and mobilising contaminants into the groundwater.	Ballymun_Image07

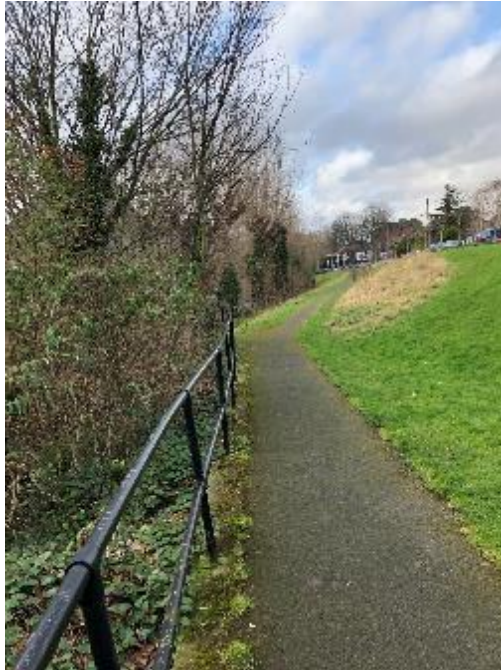
Photo ID	Caption	Date Taken	Coordinates
Ballymun_Image06	Cycle track and location of proposed construction compound along the River Tolka	07/02/2020	715369, 737242 (ITM)

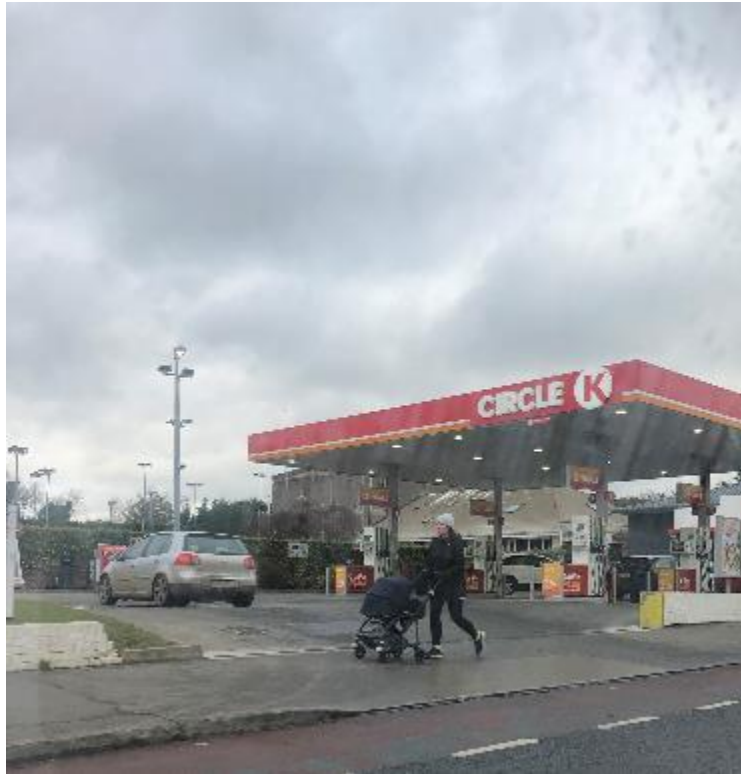
Photo ID	Caption	Date Taken	Coordinates
Ballymun_Image07	Petrol stations	07/02/2020	715251, 738334 (ITM)

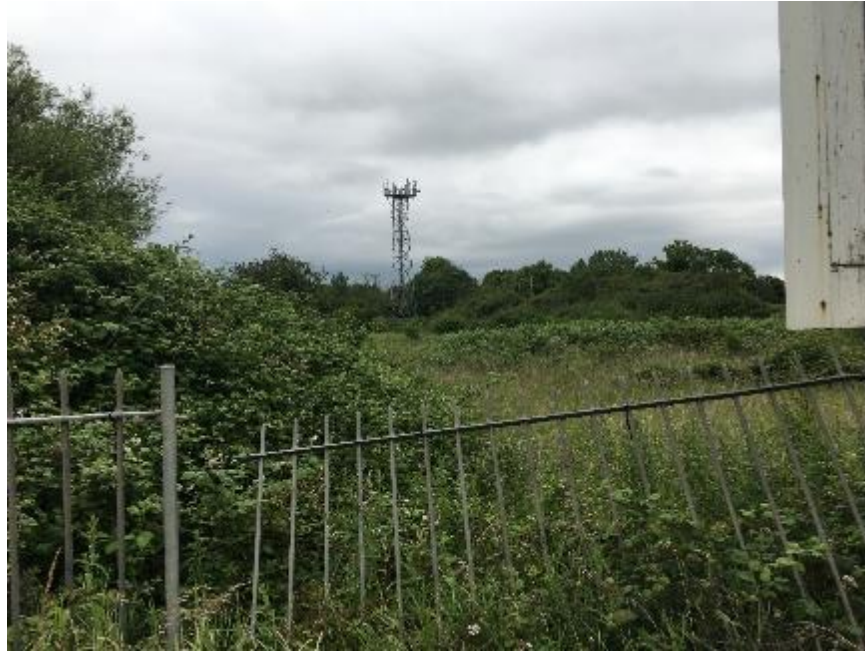
Photo ID	Caption	Date Taken	Coordinates
Ballymun_Image08	Image of proposed location for metro station at Northwood Avenue.	09/07/2021	715402, 740751 (ITM)

Proposed Metro Station – Northwood Avenue	Sheet 01, 03, 06, 10 & 13.	The maps indicate that proposed metro stations may be located at Northwood Avenue, Santry Cross, Ballymun Civic Centre, St Mobhi Road and Griffith Park.	The overlap is not known at this time.	Ballymun Image 05, 08 & 10
Proposed Construction Compound B1 at Santry Cross	20	A proposed construction compound is to be located at Santry Cross. Minor level changes were noted across the green area and topsoil will likely be stripped to accommodate the works.	This may pose an issue for the earthworks balance and waste assessment.	Ballymun Image 09

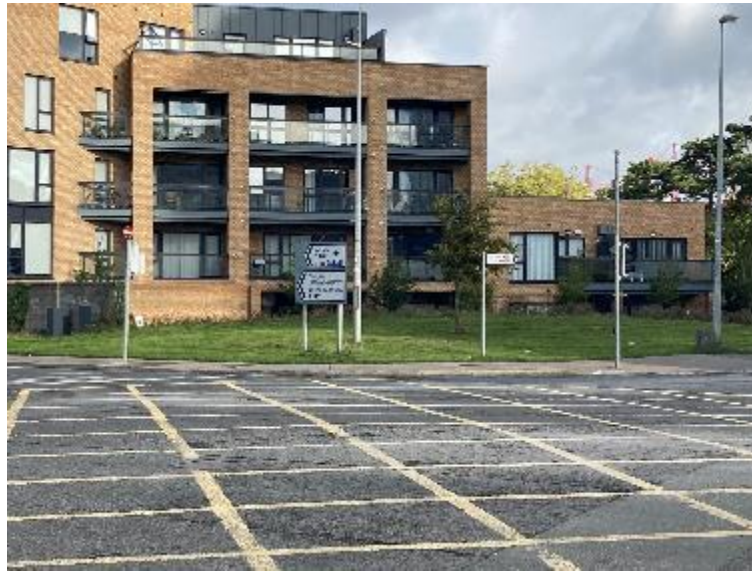
Photo ID	Caption	Date Taken	Coordinates
Ballymun_Image09	Image of proposed location for construction compound B1 at Santry Cross.	09/07/2021	715418, 740423 (ITM)

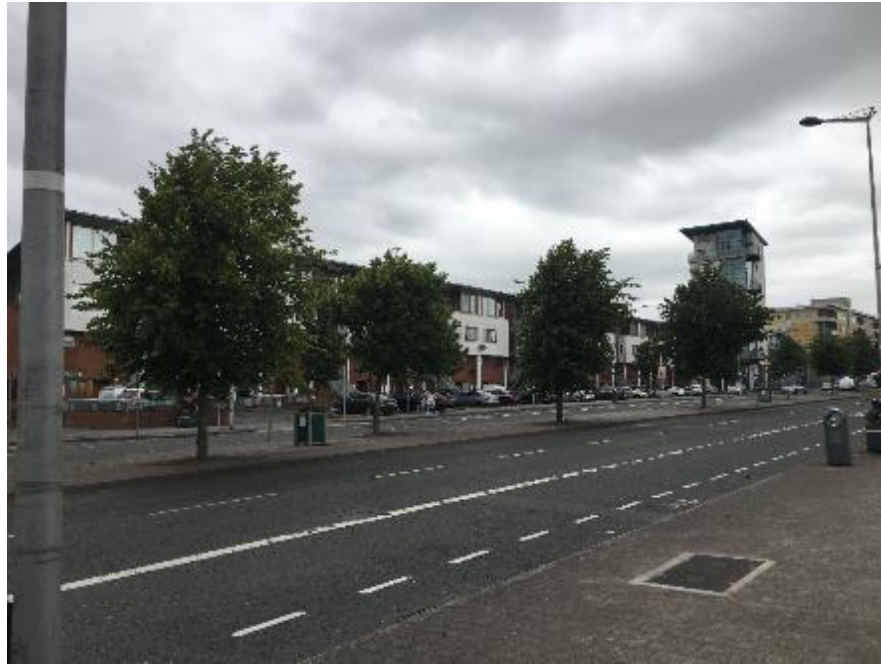
Photo ID	Caption	Date Taken	Coordinates
Ballymun_Image10	Image of proposed location of metro station at Ballymun Civic Centre.	09/07/2021	715436, 739642 (ITM)

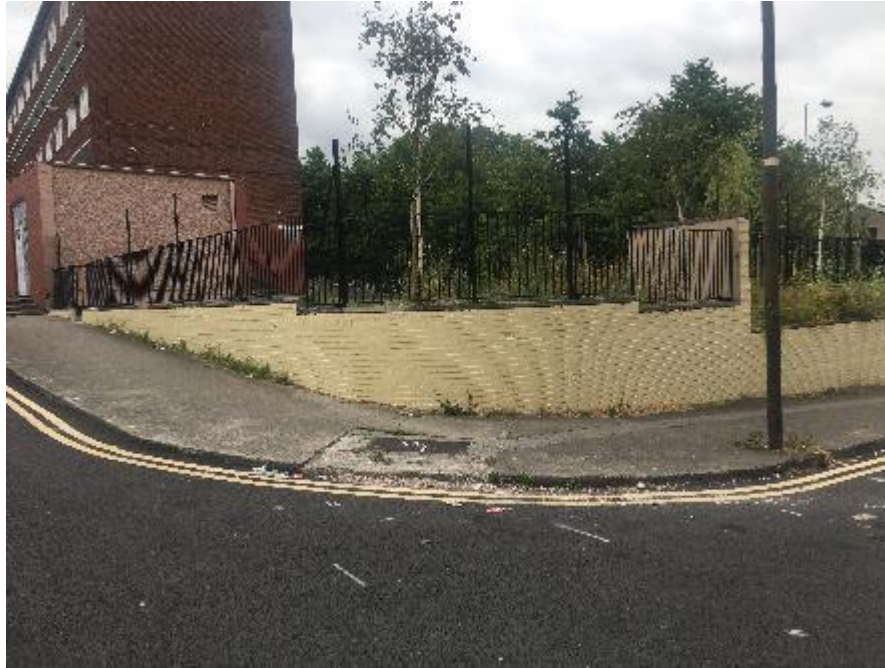
Photo ID	Caption	Date Taken	Coordinates
Ballymun_Image11	Image of proposed location of a construction compound at Constitution Hill/ Catherine Lane North Junction	09/07/2021	714896, 734888 (ITM)

Observation	General Arrangement Drawing Sheet Number*	Description	Possible Impact	Photo Number
Proposed Construction Compound B3 at Constitution Hill/ Catherine Lane North	20	A proposed construction compound is to be located at Catherine Lane North. This location is situated within an urban environment. Topsoil was noted within the site and level changes were noted on the perimeter of the site and may require the removal of boundary walls in order to access the location.	This may pose an issue for the earthworks balance and waste assessment.	Ballymun Image 11
Bachelors Stream adjacent to Finglas Road	11	The Bachelors Stream runs adjacent to the route. It was inaccessible at the time of the site walkover and is bounded by vegetation in this area.	This may pose an issue for mobilising contaminants into the groundwater and River Tolka downstream.	Screen grab from Google Imagery as inaccessible during walkover

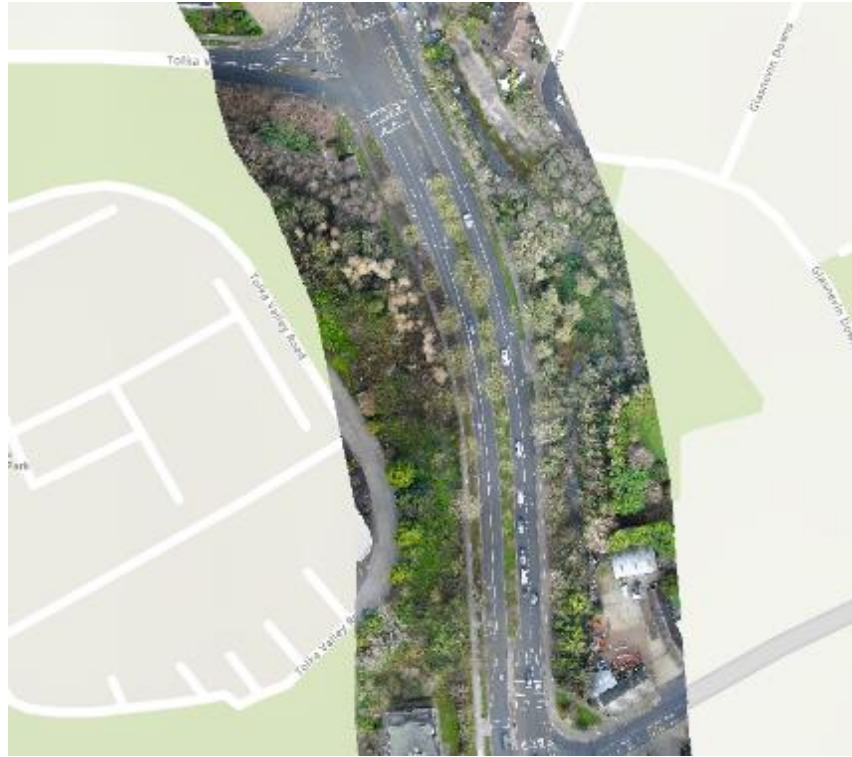
Photo ID	Caption	Date Taken	Coordinates
Screen grab from Project Drone Imagery as inaccessible during walkover	Bachelors Stream adjacent to Finglas Road	07/02/2020	713916, 737967

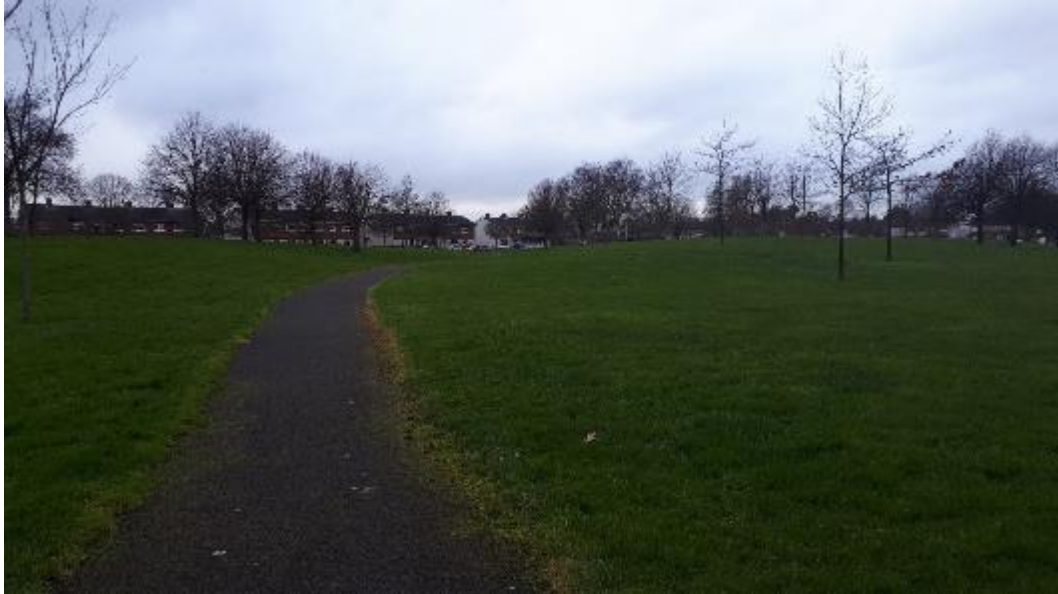
Photo ID	Caption	Date Taken	Coordinates
Finglas_Image01	Glasnevin Cemetery	07/02/2020	714616, 736829 (ITM)

Glasnevin Cemetery	12-14	The maps indicate that the road is to be widened near Glasnevin Cemetery. Minor level changes were noted in the green area across the road from the main cemetery and will likely require minor earthworks to accommodate the works.	This may pose an issue for the earthworks balance and waste assessment.	Finglas_Image01
Proposed Construction Compound at F1 at Casement Road.	01	A proposed construction compound is to be located at Casement Road, topsoil strip and minor earthworks may be required to accommodate the works.	This may pose an issue for the earthworks balance and waste assessment.	Finglas Image 02
Proposed Construction Compound F2 at Finglas Road / Finglas Place	06	A proposed construction compound is to be located at Finglas Road / Finglas Place. Minor level changes were noted in the grass verge and will likely require minor earthworks to accommodate the works.	This may pose an issue for the earthworks balance and waste assessment.	Finglas Image 03

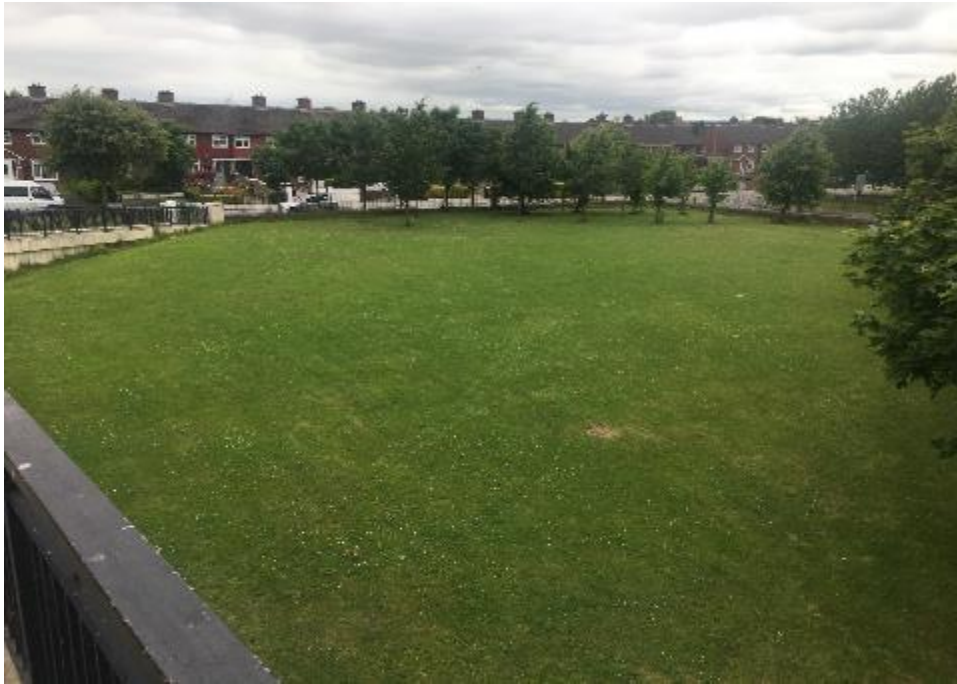
Photo ID	Caption	Date Taken	Coordinates
Finglas_Image02	Image of proposed location for a construction compound F1 at Casement Road.	09/07/2021	712679, 739543 (ITM)

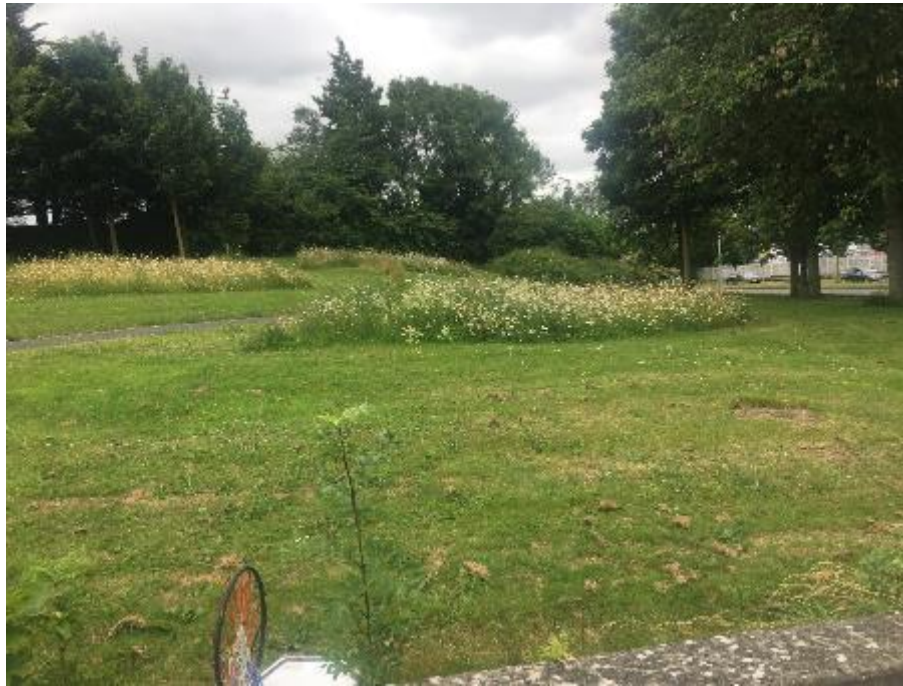
Photo ID	Caption	Date Taken	Coordinates
Finglas_Image03	Image of proposed location for a construction compound F2 at Finglas Place.	09/07/2021	713408, 738607 (ITM)

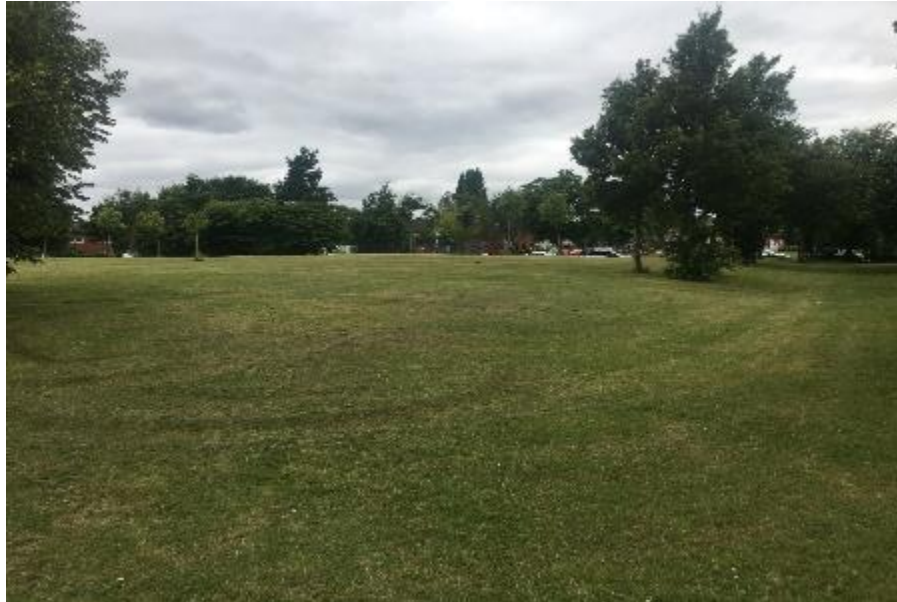
Photo ID	Caption	Date Taken	Coordinates
Finglas_Image04	Image of proposed location for construction compound F3 at Claremont Lawns – Glasnevin Cemetery.	09/07/2021	714549, 736877 (ITM)

Proposed Construction Compound F3 at Claremont Lawns, Glasnevin Cemetery	14	A proposed construction compound is to be located at Claremont Lawns. Minor level changes were noted in the grass area and will likely require minor earthworks to accommodate the works.	This may pose an issue for the earthworks balance and waste assessment.	Finglas_Image04
