Appendix VI
Aquatic Assessment

Aquatic baseline report for the BusConnects Dublin – Core Bus Corridor Infrastructure Works

Prepared by Triturus Environmental Ltd. for Scott Cawley

December 2020

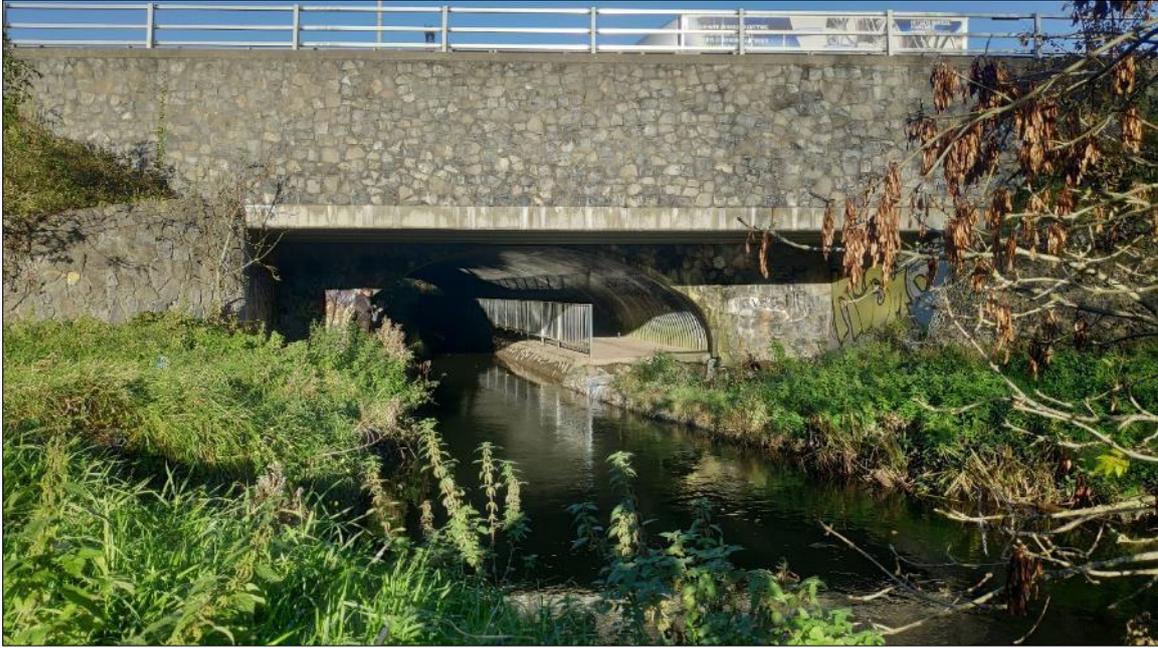
The River Tolka at site T1 was a semi-natural lowland depositing watercourse (FW2) with evident historical deepening and bank modification works. These included gabion basket scour protections and a concrete culverted bed at the N3 road crossing. The river profile mainly comprised of deep glide (60% area) and pool (30%) with more localised riffle (10%). The channel averaged 5-8m wide, with a variable depth of 0.3-1.5m deep. The channel bed comprised rendered concrete under the road crossing. However, downstream of the culvert, the substrata were dominated by boulder and cobble with pockets of very localised medium and fine gravels. The substrata were heavily bedded with 30% cover of filamentous green algae, indicating enrichment. The bed suffered from heavily siltation, albeit swift flows reduced the visible deposition levels on instream substrata. The macrophyte community was limited to small patches of emergent branched-bur reed (*Sparganium erectum*) and watercress (*Rorripa nasturtium-aquaticum* agg.). The coarse substrata on the bed also supported the aquatic moss species *Cinclidotus fontinaloides* and *Platyhypnidium riparoides* locally. The riparian habitats supported mainly scrub habitat (WS1) and rank grassy areas (GS2) with frequent nettle (*Urtica dioica*), butterbur (*Petasites hybridus*), thistles (*Cirsium* spp.) and red osier dog wood (*Cornus cericea*). Riparian trees were scattered along the banks with crack willow (*Salix fragilis*) and sycamore (*Acer pseudoplatanus*) being the most frequent species.

The river was considered a moderate quality brown trout nursery, with some localised deeper pools (including immediately downstream of the culvert) providing good holding habitat. Spawning habitat for both salmonids and lamprey was locally good (c.110m downstream of the culvert in the tailing of a pool where mobile gravel was identified, ITM 707825, 738930). The site offered poor lamprey ammocoete habitat given the high flow rates and predominance of hard substrata. European eel habitat was moderate overall. The deeper pool areas locally would support European eel (*Anguilla anguilla*). White-clawed crayfish are not present in the River Tolka (no known records) and were not recorded during the survey. Otter spraint (1 site (3 spraints)) was recorded under the culvert in a muddy area of the west bank (ITM 707817, 739019).

Plate 3.1 Representative image of site T1 on the River Tolka (facing upstream towards culvert)

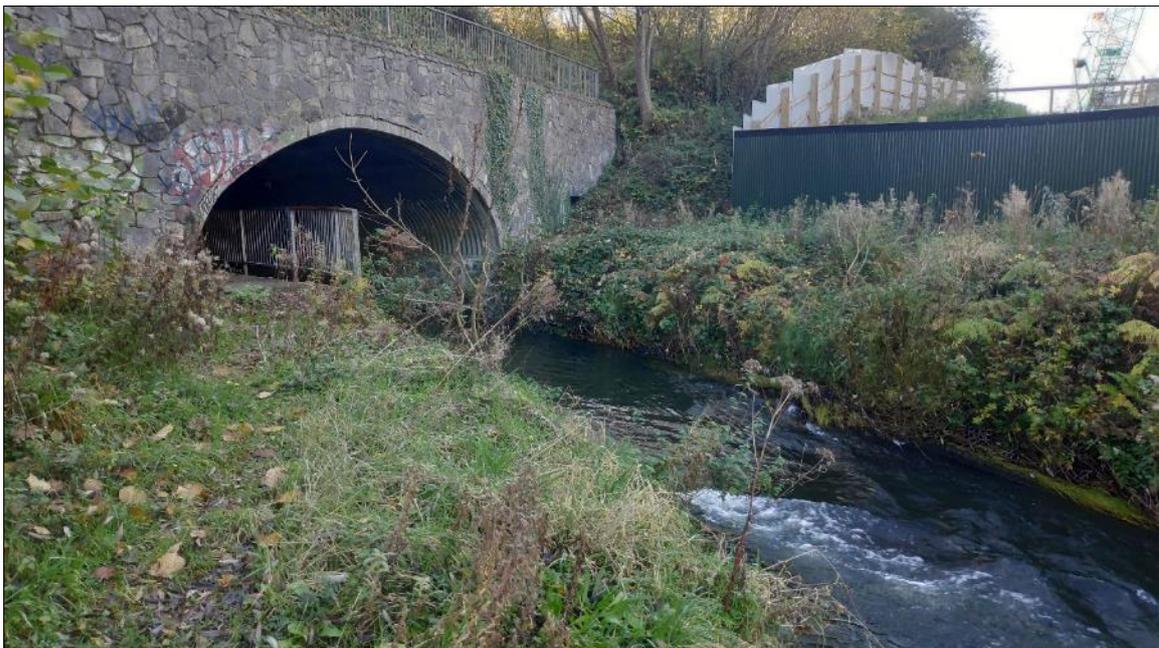
The River Tolka at site T2 was a semi-natural lowland depositing watercourse (FW2) with a swift flow and a well-defined thalweg downstream of the bridge crossing and associated culvert. Located approx. 0.5km downstream of site T1, the river profile was dominated by glide (50%) and riffle (40% area) with more localised pool 10%. The channel width was variable between 6m and 14m wide. The depth was also variable and recorded between 0.4m and 1.0m deep. The good semi-natural character for an urban river, however, was diminished by riverine substrata that were in poor condition due to siltation pressures. Furthermore, hydro-morphologically the river had been altered at the N3 crossing with the channel bed comprising of rendered concrete with little gravel or cobble deposition under the road crossing. Downstream of the culvert, the bed comprised bedrock, boulder and cobble with very localised pockets of medium and fine gravels. The substrata were very however, heavily bedded and covered by filamentous green algae (205 surface area cover, indicating enrichment). While the bed suffered from heavily siltation, the swift flows reduced the visible deposition levels on the visible instream substrata (as with other areas on the River Tolka). The macrophyte community comprised locally frequent watercress (*Rorippa nasturtium-aquaticum* agg.) and lesser water parsnip (*Berula erecta*) in the margins. The coarse substrata on the bed also supported *Cinclidotus fontinaloides* and *Platyhipnidium riparoides* locally. The riparian habitats supported mainly scrub habitat and rank grassy areas with frequent winter heliotrope, nettle, bramble (*Rubus fruticosus* agg.), bracken (*Pteridium aquilinum*), buddleja (*Buddleja davidii*), hemp agrimony (*Eupatorium cannabinum*), spear thistle (*Cirsium vulgare*) and hogweed (*Heracleum sphondylium*). The banks supported a few scattered mature crack willow (*Salix fragilis*), with a more mature treeline downstream of the survey area. The river upstream of the culvert was narrower, very fast flowing and heavily overgrown with scrub. Historical bank works were evident with gabion baskets present.

The river was considered a moderate brown trout nursery, with some localised deeper pools providing good holding habitat. Spawning habitat for both salmonids and lamprey was poor given substrata compaction and bedding. Swift flows largely precluded sediment deposition but some superficial silts were present marginally which provided some limited suitability for *Lampetra* sp. ammocoetes. European eel habitat was moderate overall albeit compaction of the bed and swift flows provided for less optimal refugia. White-clawed crayfish are not present in the River Tolka (no known records) and were not recorded during the survey. Regular otter spraint sites were recorded on the concrete path on the downstream side (ITM 708122, 738814) and upstream side of the culvert (ITM 708095, 738790).

Plate 3.2 Representative image of site T2 on the River Tolka (facing upstream towards culvert)

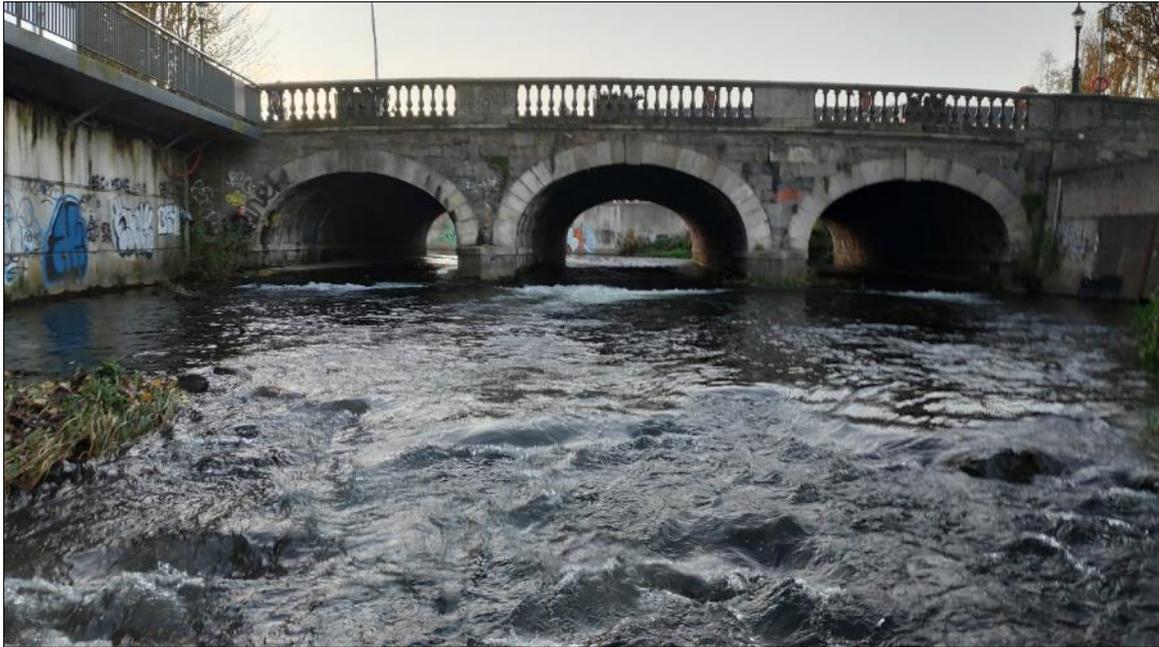
The River Tolka at site T3 was a semi-natural lowland depositing watercourse (FW2) with a swift flow. Despite being located in a heavily urbanised area with high retaining walls, the river profile was surprisingly natural downstream of the bridge (upstream being glide dominated, held between retaining walls and with less natural character). The river profile was dominated by glide (30%) and riffle (50%) with more localised pool 20% (the largest of which was located immediately downstream of the bridge apron/weir). The channel width was variable between 15m and 20m wide, being narrower downstream where marginal riparian stands of osier (*Salix viminalis*), grey

Downstream of the bridge, the river was considered a good brown trout nursery and good holding area for adult fish. Spawning for both salmonids and lamprey was considered locally good, despite siltation pressures. Upstream of the bridge the river was mainly a holding area for salmonids with deeper glide habitat held between retaining walls. Lamprey ammocoete habitat was sparse given the high energy nature of the site. European eel habitat was good downstream of the bridge owing to ample boulder refugia and deeper pool areas. White-clawed crayfish are not present in the River Tolka as previously described for other survey areas and none were recorded during the survey. A regular otter spraint site (1(6), mixed age) was recorded on the bridge apron downstream of the bridge (south bank) (ITM 716124, 736756).

Plate 3.3 Representative image of site T3 on the River Tolka at Frank Flood Bridge (facing upstream)

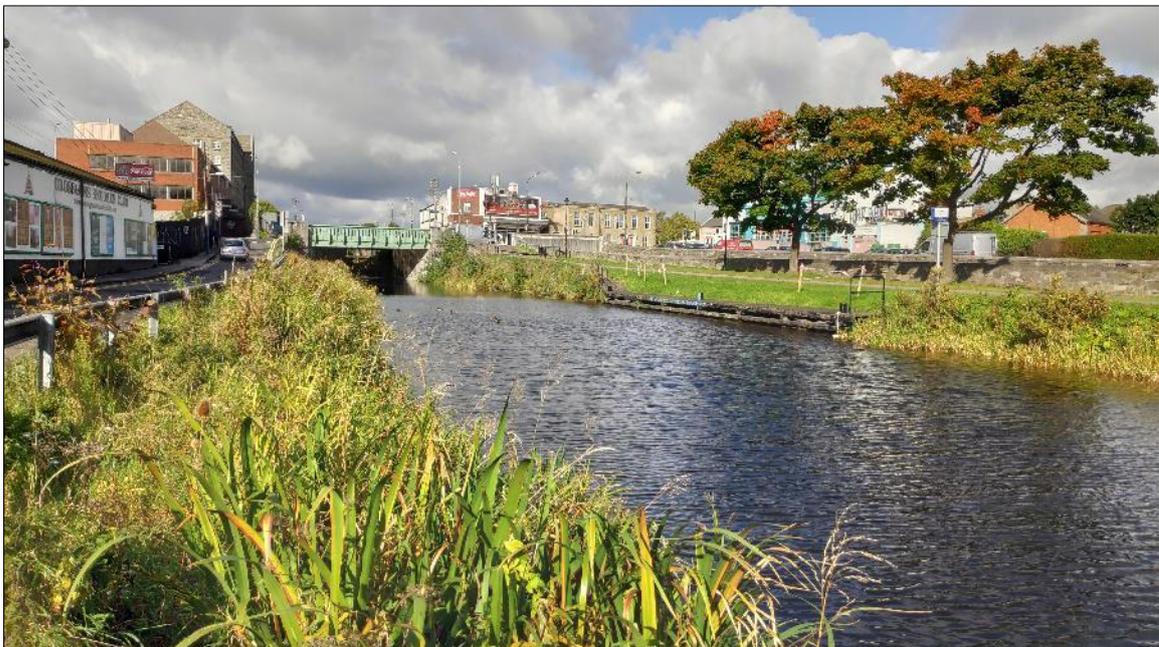
The Royal Canal between the 4th and 5th lock (level 4, Phibsborough) was a uniform 10-12m wide and 1.5-2.5m deep, with a centrally deeper navigation channel in most areas. The substrata were dominated by silt with high clay fractions (often >0.3m in depth), with scattered boulder and localised marginal cobble/gravel areas (e.g. along boat gangway). The 300m section of canal (between the 4th and 5th locks) was typified by narrow riparian fringes bordered by urban areas and built land (BL3). The riparian zones supported a range of common species such as great willowherb (*Epilobium hirsutum*), nettle, meadowsweet, yarrow (*Achillea millefolium*), marsh ragwort (*Jacobaea aquatica*), hedge bindweed (*Calystegia sepium*), creeping thistle, hogweed and occasional teasel (*Dipsacus fullonum*). Non-native Canadian fleabane (*Conyza canadensis*) and buddleja were both occasional. Intermittent planted treelines of sycamore and cherry (*Prunus* sp.) were present in maintained grassland strips (WD5 parkland habitat). The canal margins were lined by narrow linear strips dominated by reed sweet grass (*Glyceria maxima*) with frequent stands of iris (*Iris pseudacorus*) and occasional reed canary grass. Instream, the macrophyte community was dominated by yellow lily (*Nuphar lutea*) (both submerged and emergent forms), with common duckweed (*Lemna minor*) and ivy-leaved duckweed (*Lemna trisulca*) being frequent. Also frequent was Canadian pondweed (*Elodea canadensis*), Nuttall's pondweed (*Elodea nuttallii*), whorled-water milfoil (*Myriophyllum verticillatum*) and stonewort species *Chara* sp. Amphibious bistort (*Persicaria amphibia*) was occasional on bank and in margins. The rare and protected opposite-leaved pondweed (*Groenlandia densa*) is known from this area of the Royal Canal (BEC, 2011; NPWS data) but no stands were observed during the survey (October 2020). It is considered likely that the species is still present but given it is a dark green, submerged pondweed that often sprawls along the bottom, its detection can be difficult.

Overall, site RC1 offered excellent coarse fish habitat for a range of common species including roach (*Rutilus rutilus*), bream (*Abramis brama*), perch (*Perca fluviatilis*) and pike (*Esox lucius*). Well-vegetated canal sections such as this provide valuable nursery habitat for numerous fish species, in addition to good spawning substrata in the spring/early summer months. European eel are known from this section of canal and habitat was considered good. No white-clawed crayfish are known from the eastern extent of the Royal Canal in Dublin City (NBDC, NPWS data, pers. obs.), despite some good physical habitat and physiochemical suitability. No otter signs were recorded during the site visit although suitable marking areas were largely absent.

Plate 3.4 Representative image of site RC1 on the Royal Canal at Phibsborough (5th lock)

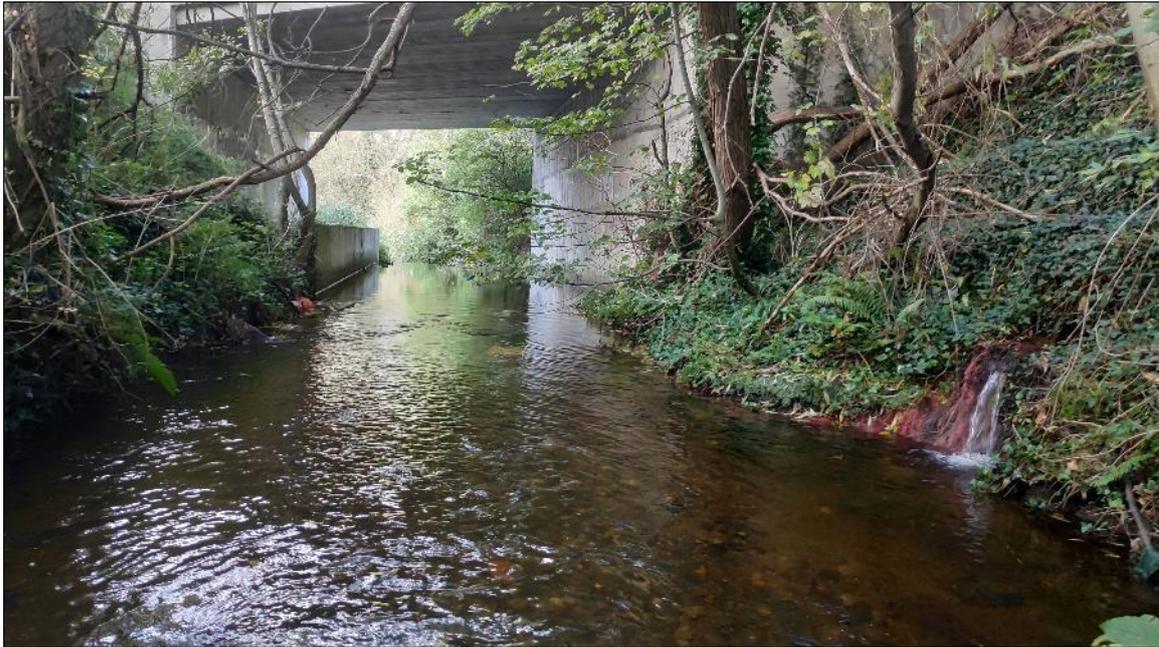
The Owendoher at site O2 was located at the R114 road bridge/culvert, approx. 100m downstream from site O1. Here, the river averaged 6-7m wide and 0.3-0.6m deep, with localised deeper pool and glide areas to 1.2m. The river flowed through a semi-natural V-shaped valley with bankfull heights of 7-8m (steep sided) and was bound by masonry retaining walls under the bridge. In contrast to site O1 upstream, the site was characterised by slower, deeper glide and pool. Downstream of the weir, riffle predominated. The substrata were dominated by partially bedded cobble (30%) with clean sand (30%) and well-sorted gravels (20% overall). There were extensive beds of coarse sand locally. Large boulder was frequent (20%). Siltation was low with any accumulations of finer substrata dominated by sand. Erosion from floods and human interference was evident along both banks. As per site O1, the river was isolated from human activity with poor access via steep banks. The banks supported mature treelines dominated by sycamore, crack willow, ash and elder (*Alnus glutinosa*), with occasional cherry laurel. Buddleja was present downstream of the bridge. The scrubby escarpments supported bramble and ivy with angelica and hedge bindweed. Japanese knotweed and winter heliotrope was scattered throughout the site (but more prevalent upstream). Riparian shading was relatively high and macrophytes were absent. The aquatic moss layer was poorly developed with only localised *Platyhypnidium riparoides* present, with *Hygroamblystegium tenax* on the weir face. The bridge retaining walls did not support vegetation.

Site O2 offered excellent salmonid habitat, with particularly good spawning opportunities given abundant clean substrata. Holding habitat was also excellent (particularly underneath the bridge) although the weir was a significant barrier to fish migration (no fish pass present). Brown trout were plentiful. The site was also a good salmonid nursery (likely brown trout only given known migration barriers downstream). Whilst the site offered some good physical suitability for lamprey spawning, the swift flows and general eroding/spate nature precluded fine sediment deposition and larval habitat was largely absent. European eel habitat was moderate. White-clawed crayfish are not known in the Owendoher. Old otter spraint (1(2)) was recorded under the bridge structure on the west bank (ITM 714179, 728878).

Plate 3.6 Representative image of site O2 on the Owendoher River (facing downstream towards road bridge with point source evident in right foreground)

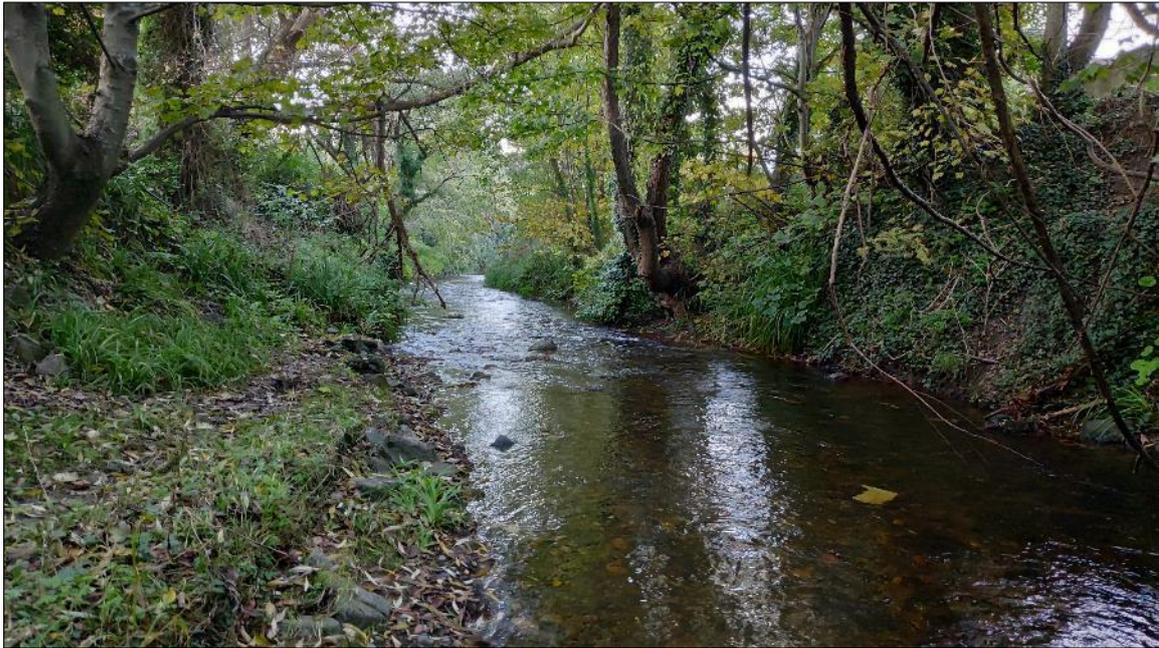
Site O3 on the Owendoher River was located approx. 100m downstream from the R114 road bridge (site O2). Here, the swift-flowing river averaged 6-8m wide and 0.2-0.4m deep, with locally deeper pool to 0.8m. The site was typified by shallow fast glide and riffle (both 40%), with only localised small pools present. The substrata featured more in the way of cobble (40%) and boulder (30%) in comparison to upstream areas, although coarse sands and finer gravels were still frequent (30% overall). Siltation was low and any fine sediment accumulations present were sand-dominated. The river flowed in a semi-natural deep U-shaped valley with steep banks colonised by mature treelines supporting sycamore, elder, hawthorn (*Crataegus monogyna*), alder and ash with occasional crack willow and cherry laurel. The understories featured common species such as ivy, pendulous sedge, tutsan (*Hypericum androsaemum*), wood avens (*Geum urbanum*), pignut (*Conopodium majus*), hogweed and ferns. Non-native three-cornered garlic (*Allium triquetrum*), listed on the Third Schedule of the European Communities (Birds and Natural Habitats) Regulations 2011-2015, was present locally along with winter heliotrope. Non-native Abraham-Isaac-Jacob (aka. oriental borage) (*Trachystemon orientalis*) had escaped from an adjacent garden and was present along the river (west bank). Riparian shading was relatively high and macrophytes were absent (as per upstream). *Platyhypnidium riparoides* was present locally on larger boulder. Filamentous algae was also present (1% cover only). The liverworts *Marchantia polymorpha* and *Conocephalum conicum* were present on muddy banks.

Plate 3.7 Representative image of site O3 on the Owendoher River (facing downstream)

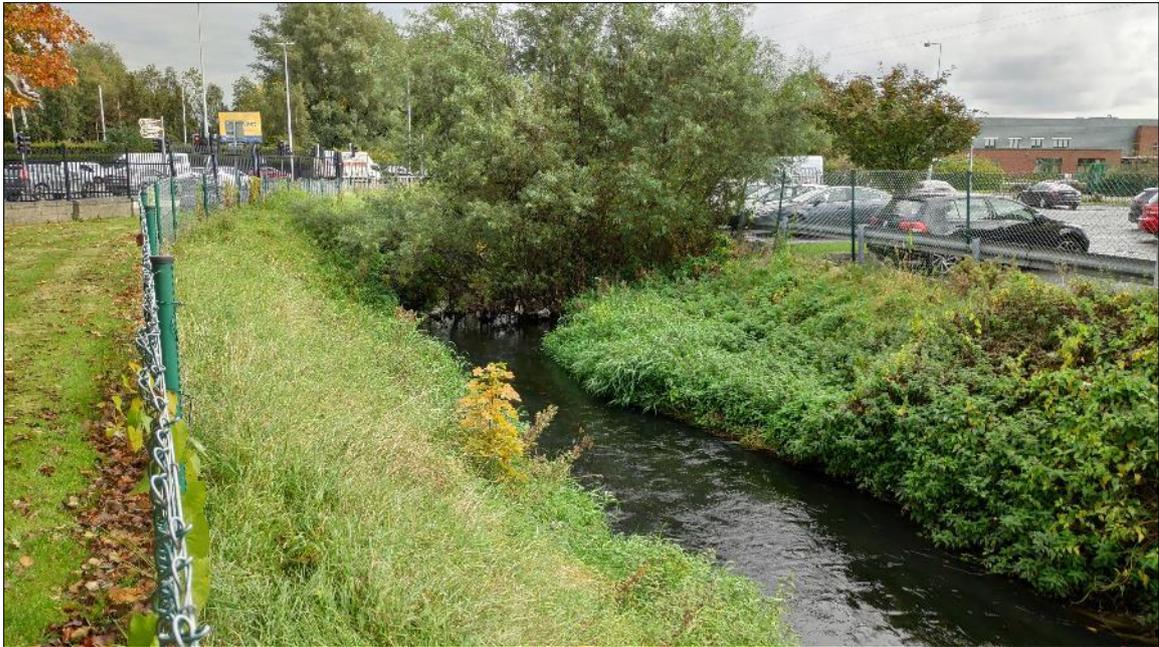
Site C2 offered some very good salmonid habitat (brown trout only). Upstream of the culvert provided excellent quality spawning and nursery habitat (among the best on the entire river) with very good holding habitat for abundant adult trout in undercut banks/under overhanging reed canary grass. A single mature crack willow immediately upstream of the culvert also provided an excellent deep holding pool for adult salmonids. Downstream, whilst spawning and nursery value was somewhat reduced, adult holding habitat was very good given undercut banks and prominent submerged tree roots (willow and sycamore). These also offered excellent refugia for white-clawed crayfish, which were recorded at 'moderate' densities (≥ 1 to < 3 per 10 refugia; Peay, 2003). A total of $n=8$ crayfish were recorded via sweep netting, with males, females and juveniles present, ranging from 19-41mm carapace length. Lamprey ammocoete habitat was present both upstream and downstream of the culvert, usually in association with instream macrophyte beds. European eel habitat was good throughout but better upstream. Despite known utilisation of the river and abundant prey resource, no otter signs were recorded during the site visit (few suitable marking sites present).

Plate 3.10 Representative image of site C2 on the River Camac (upstream of the culvert)

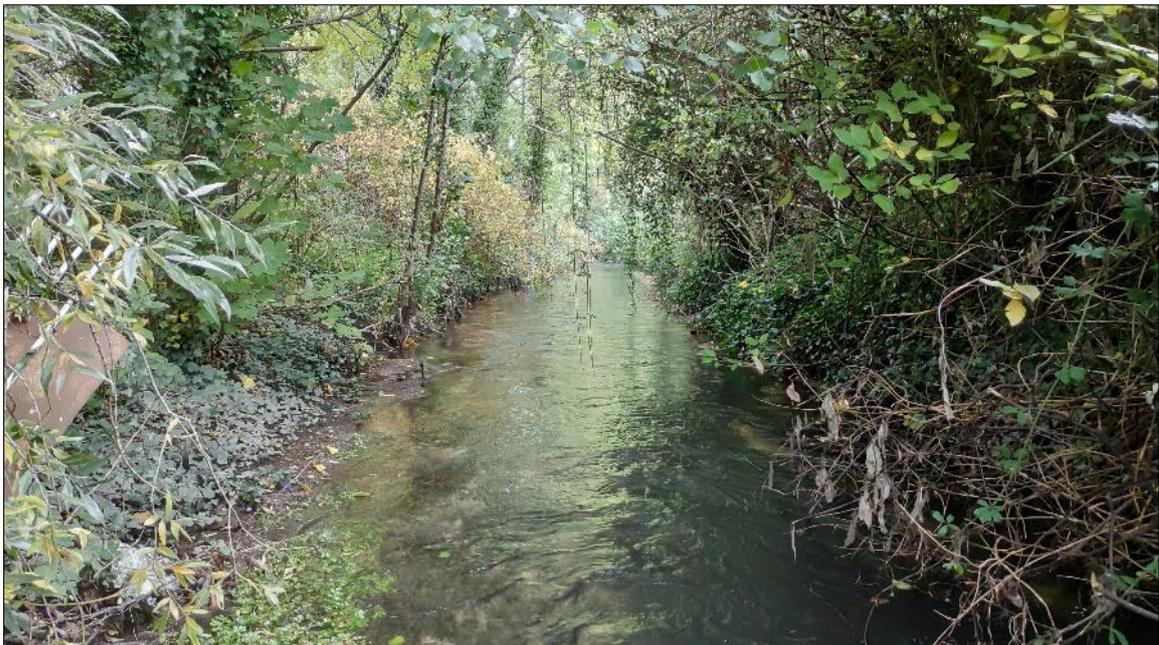
Plate 3.11 Representative image of site C2 on the River Camac (downstream of the culvert)

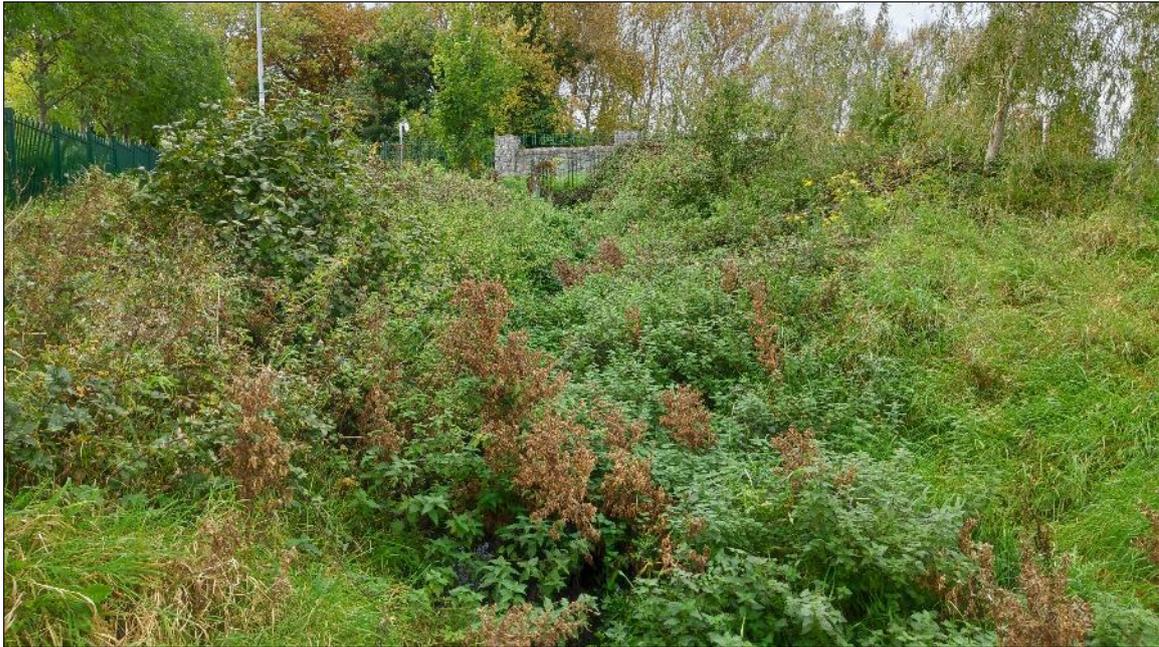
Site P1 was found to have low fisheries value and poor water quality, and of low overall aquatic ecological value.

Plate 3.12 Representative image of site P1 on the upper reaches of the River Poddle (heavily scrubbed-over, facing upstream to road crossing)
